**PROJECT TITLE:**  
**JOLIET JUNIOR COLLEGE  
LOOP ROAD RETAINING  
WALL RESTORATION**

**DRAWING TITLE:**  
**RESTORATION  
PLAN**

**DRAWING No.**  
316-1162-C1  
**SCALE:**  
AS NOTED  
**SHEET C100**

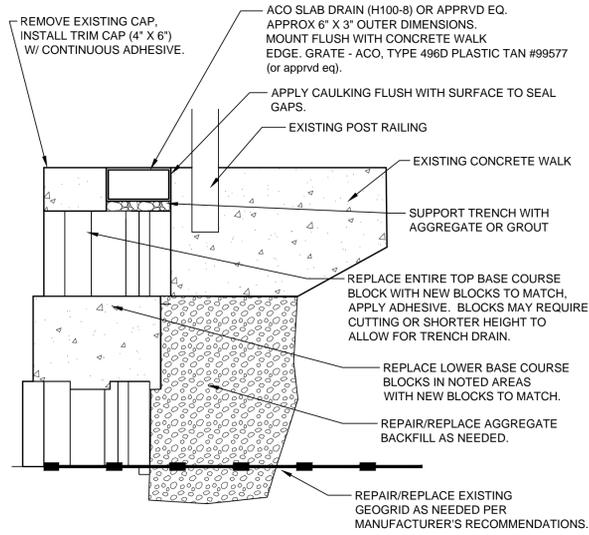
**1** TRENCH DRAIN - WALL RESTORATION SECTION  
1 1/2" = 1'-0"  
PR-PU-JJC3-02

- TRENCH DRAIN SYSTEM TO BE ACO SLABDRAIN H100-8 CHANNEL WITH PLASTIC GRATE TYPE 496D #99577 (or aprvrd eq.). LENGTH APPROXIMATELY 246 LINEAR FEET.
  - ANY GEOGRID LAYERS/AREAS DISTURBED BY CONSTRUCTION SHALL BE REPAIRED/REPLACED PER MANUFACTURER'S RECOMMENDATIONS FOR INSTALLATION.

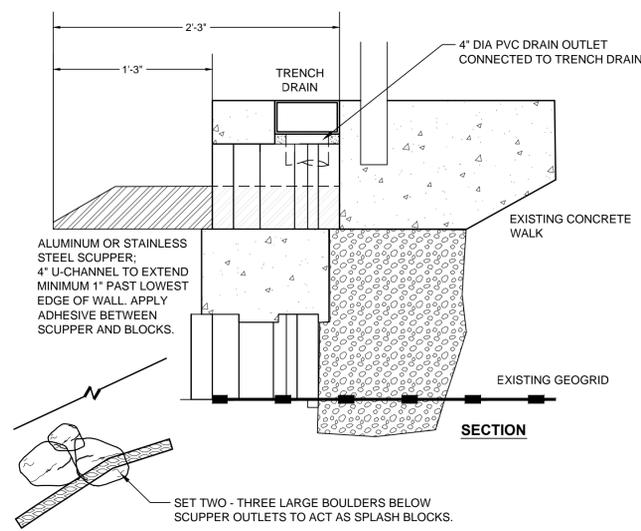
**2** WALL DRAIN OUTLET DETAIL  
1 1/2" = 1'-0"  
PR-PU-JJC3-03

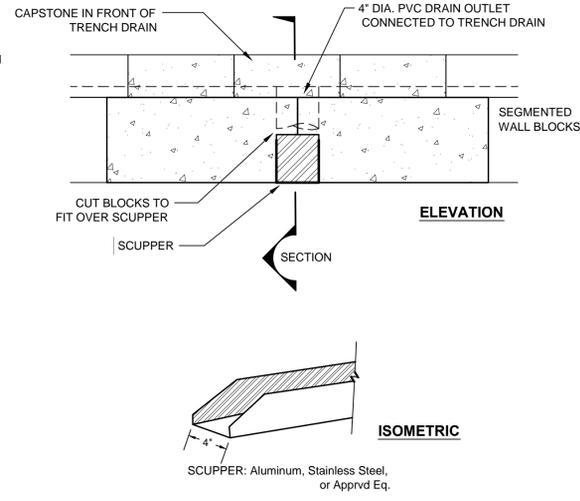
- NOTES:**
- SECTION ELEVATION ABOVE IS SHOWN FOR REFERENCE AND TAKEN FROM ORIGINAL DESIGN DRAWINGS. DO NOT SCALE FROM DRAWING. REFER TO ORIGINAL DESIGN DRAWINGS BY BLDD ARCHITECTS (date 3-1-2005) FOR ADDITIONAL DETAIL.
